## **SERVICE BULLETIN**

# <sub>N°</sub> 169-148

#### ATA 64 - TAIL ROTOR FLIGHT CONTROL IMPROVED PERIODICAL INSPECTION

This Service Bulletin is issued in order to require the periodical inspection of the slippage marking of the back-end castellated nut of the TR servo-actuator and the periodical detailed inspection of the TR duplex bearing.

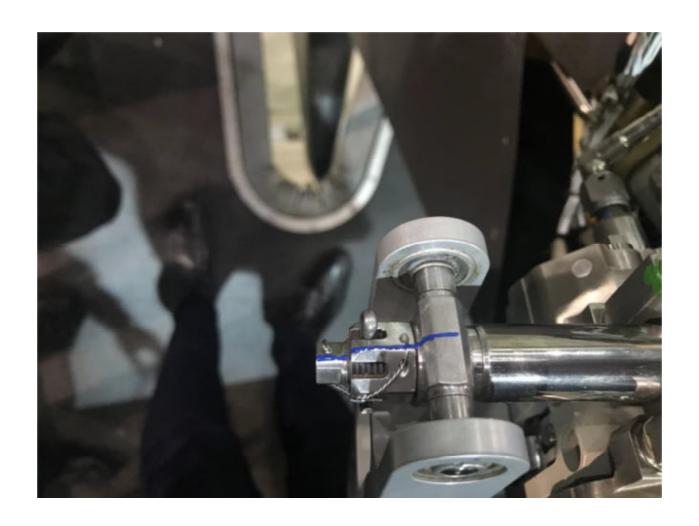
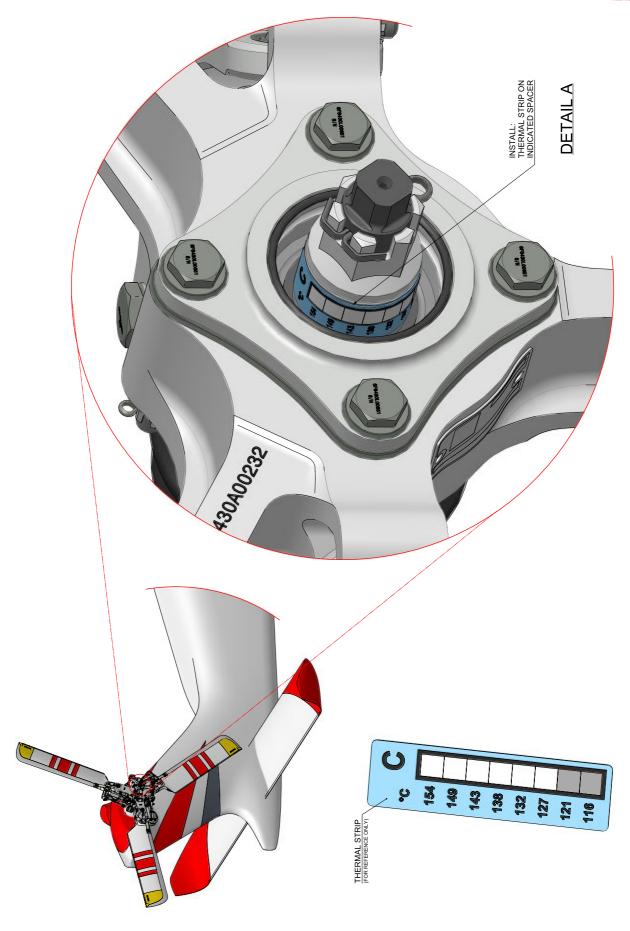
Figure 4

- 4. With reference to Figure 4, check the temperature reached by the thermal strip installed on spacer control rod P/N 4F6430A02551. Make sure that the temperature has not reached a value equal to or above 121°C. Record the check result on Table III (refer to Figure 9).

3.3 With reference to Figure 4, with the help of a non metallic spatula, perform the installation of the thermal strip on the surface of the spacer control rod P/N 4F6430A02551.

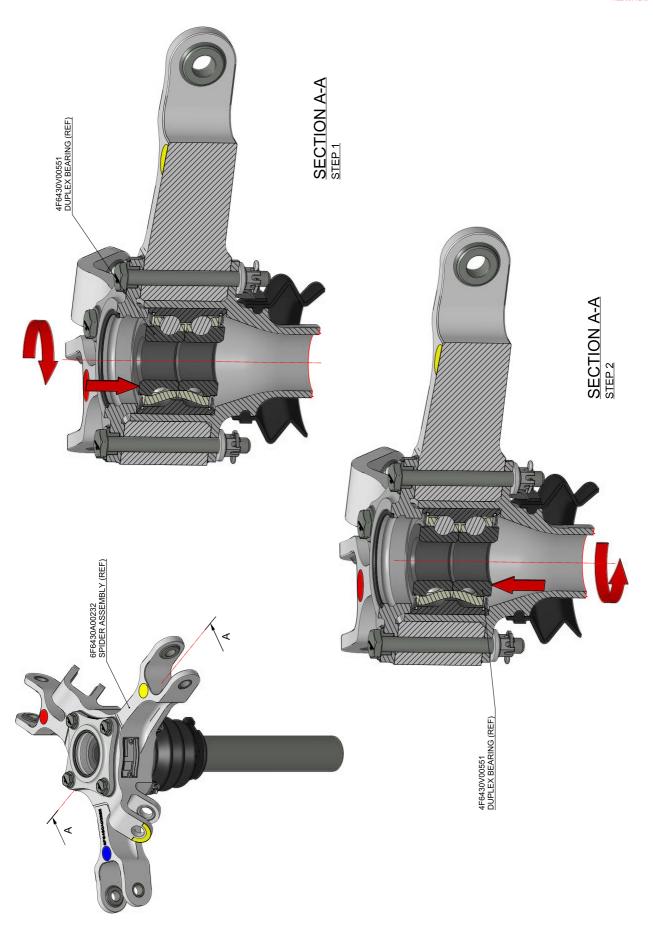
- 5.2 With reference to Figure 6 section A-A Step 1, push the top inner race down and at the same time turn it to feel if there is roughness.
- 5.3 Put your finger into the duplex bearing until you can pull up the lower face of the inner race.

- 5.4 With reference to Figure 6 section A-A Step 2, pull the bottom inner race in the up direction and at the same time turn it to feel if there is roughness.
- 5.5 Repeat the Step 5.1 thru Step 5.4 at least one time to confirm the results.
- 5.6 Record the results of the previous steps on Table V (refer to Figure 11).
